Effects of bank vegetation in waterways with special reference to bank erosion, shear strength, root density and channel hydraulics

**Effects of Bank Vegetation in Waterways with Special
Reference to Bank Erosion, Shear Strength, Root Density and
Channel Hydraulics**

**A thesis submitted to the Open University
for the Degree of Doctor of Philosophy
Biology Department
September 1992**

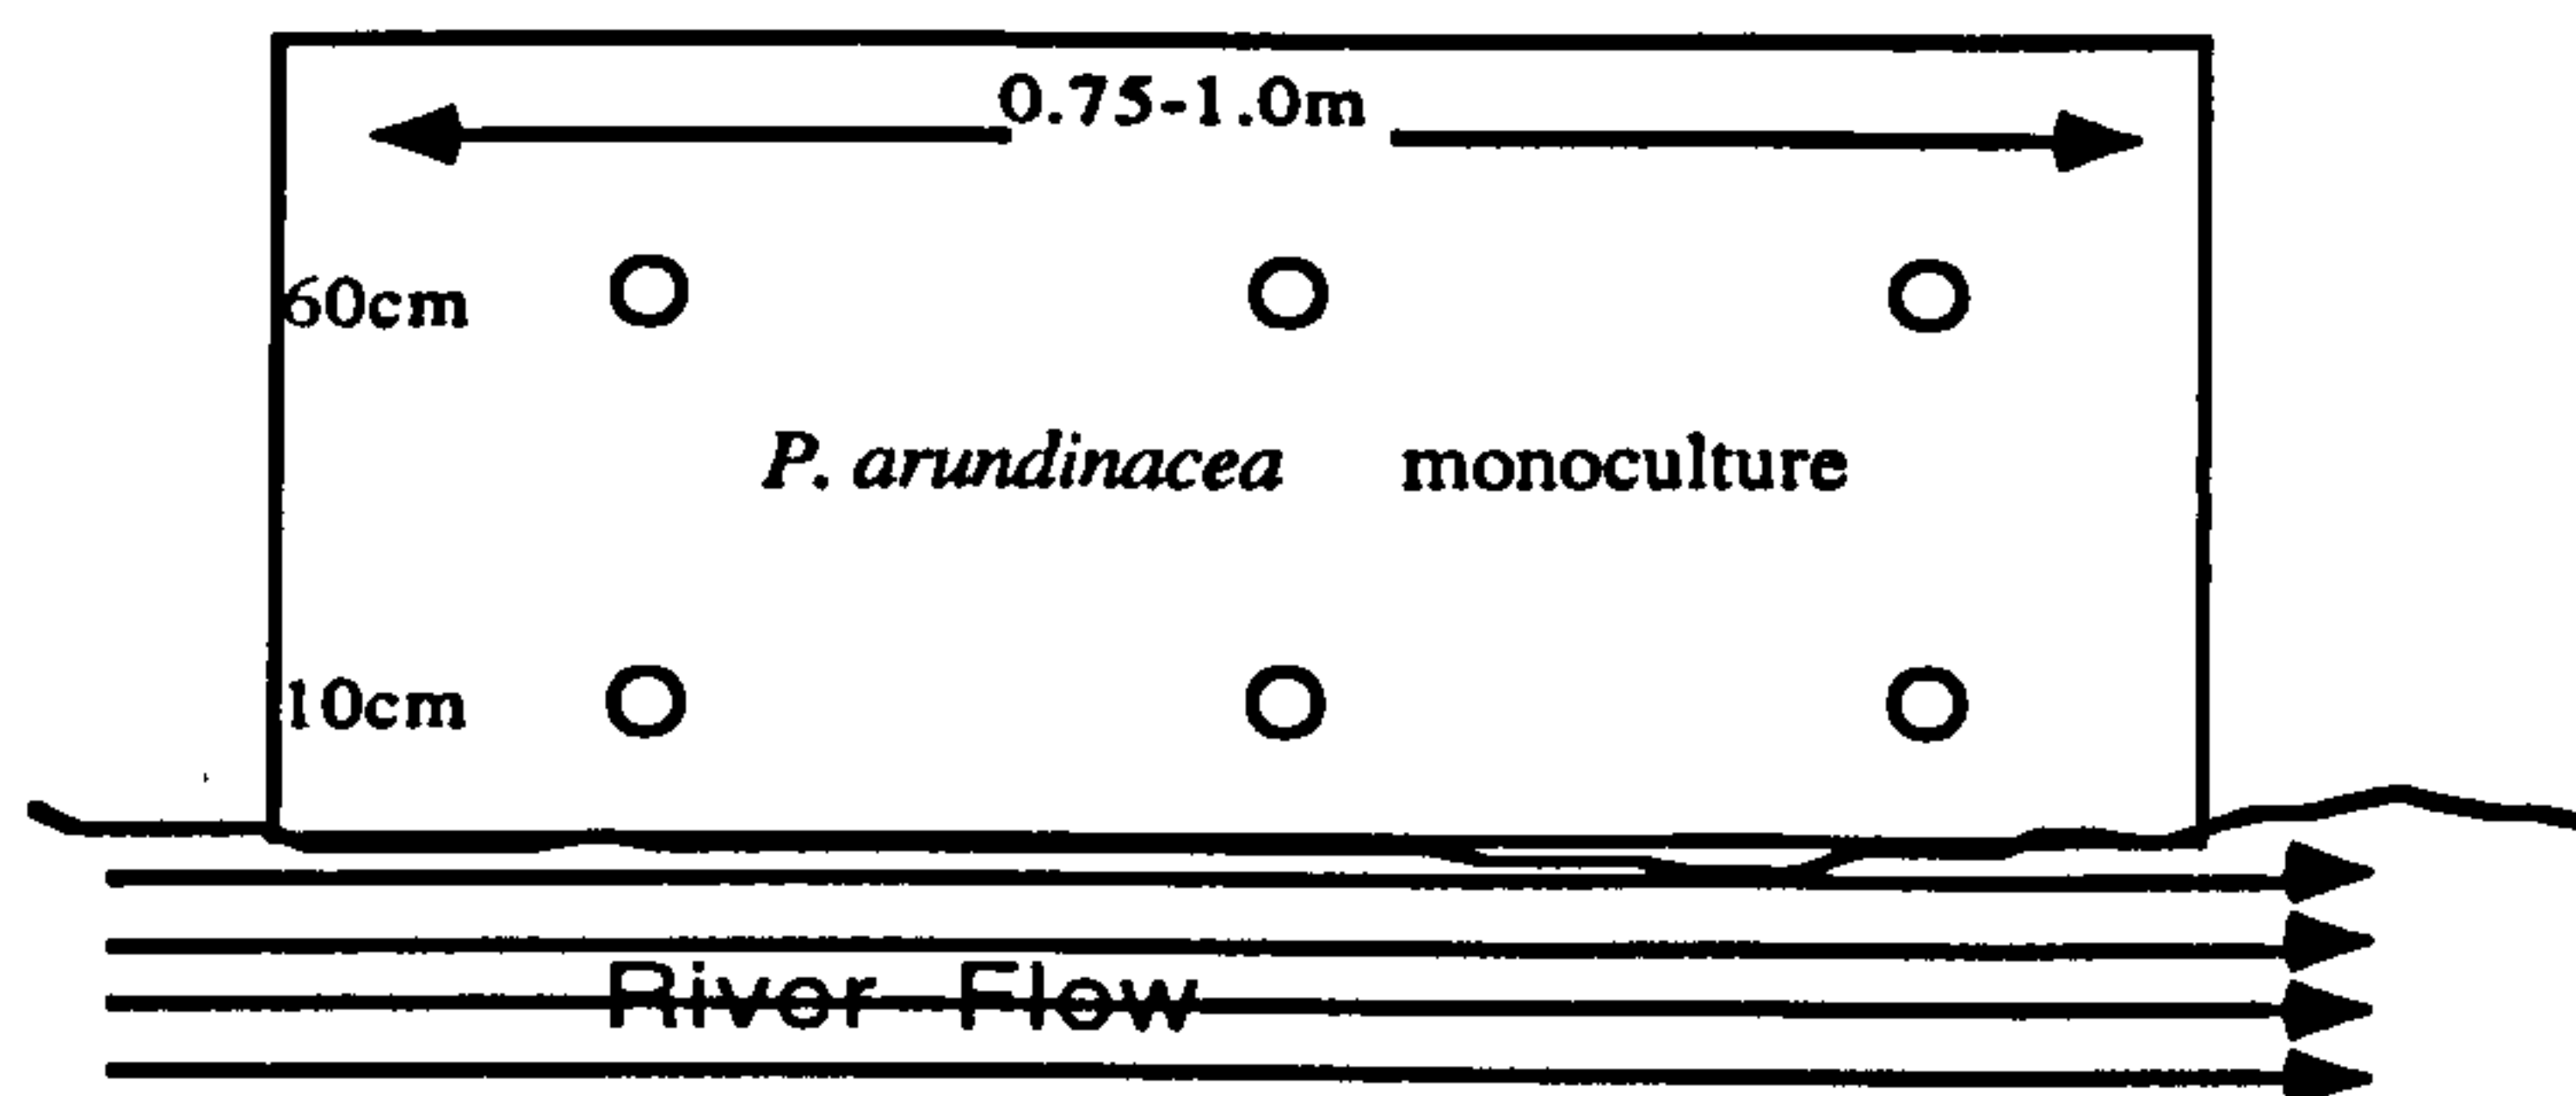
Fig. 6.2 : Sampling pattern for Shear strength, Moisture content and Total root length per unit volume of soil in a monoculture area of *Phalaris arundinacea*.

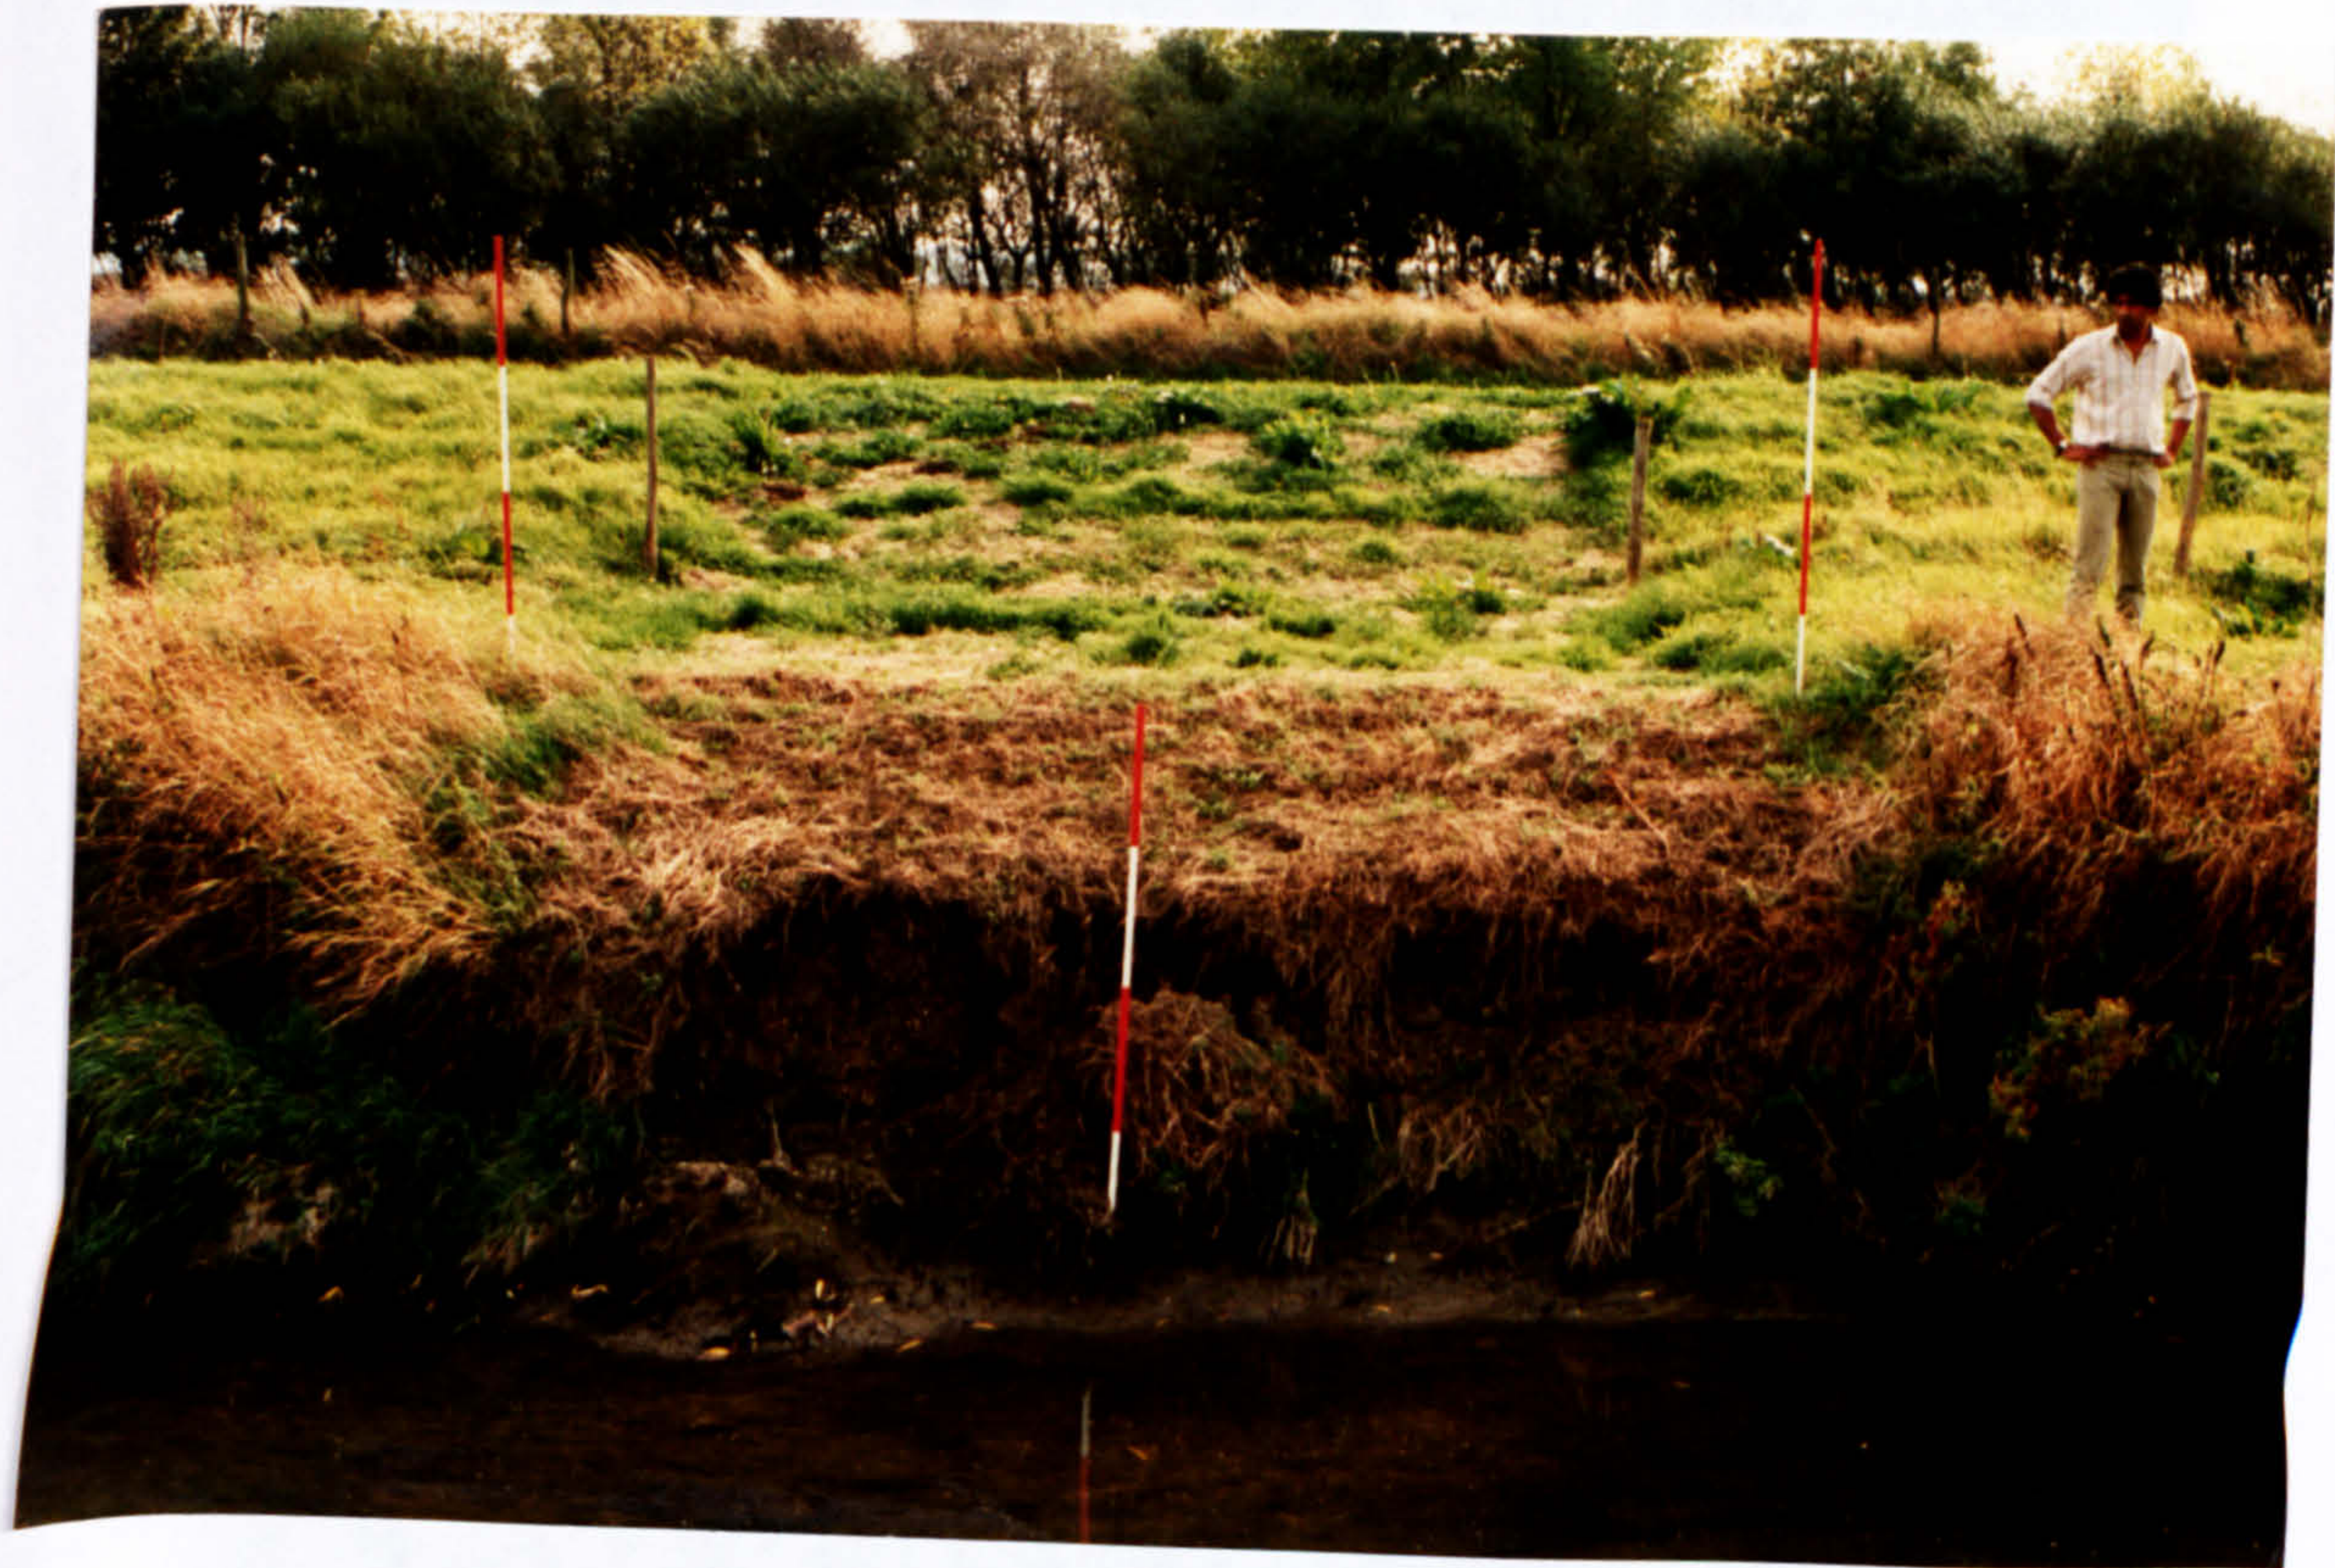
Plate 13. Mid-bank slumping as a result of denudation by a systemic herbicide

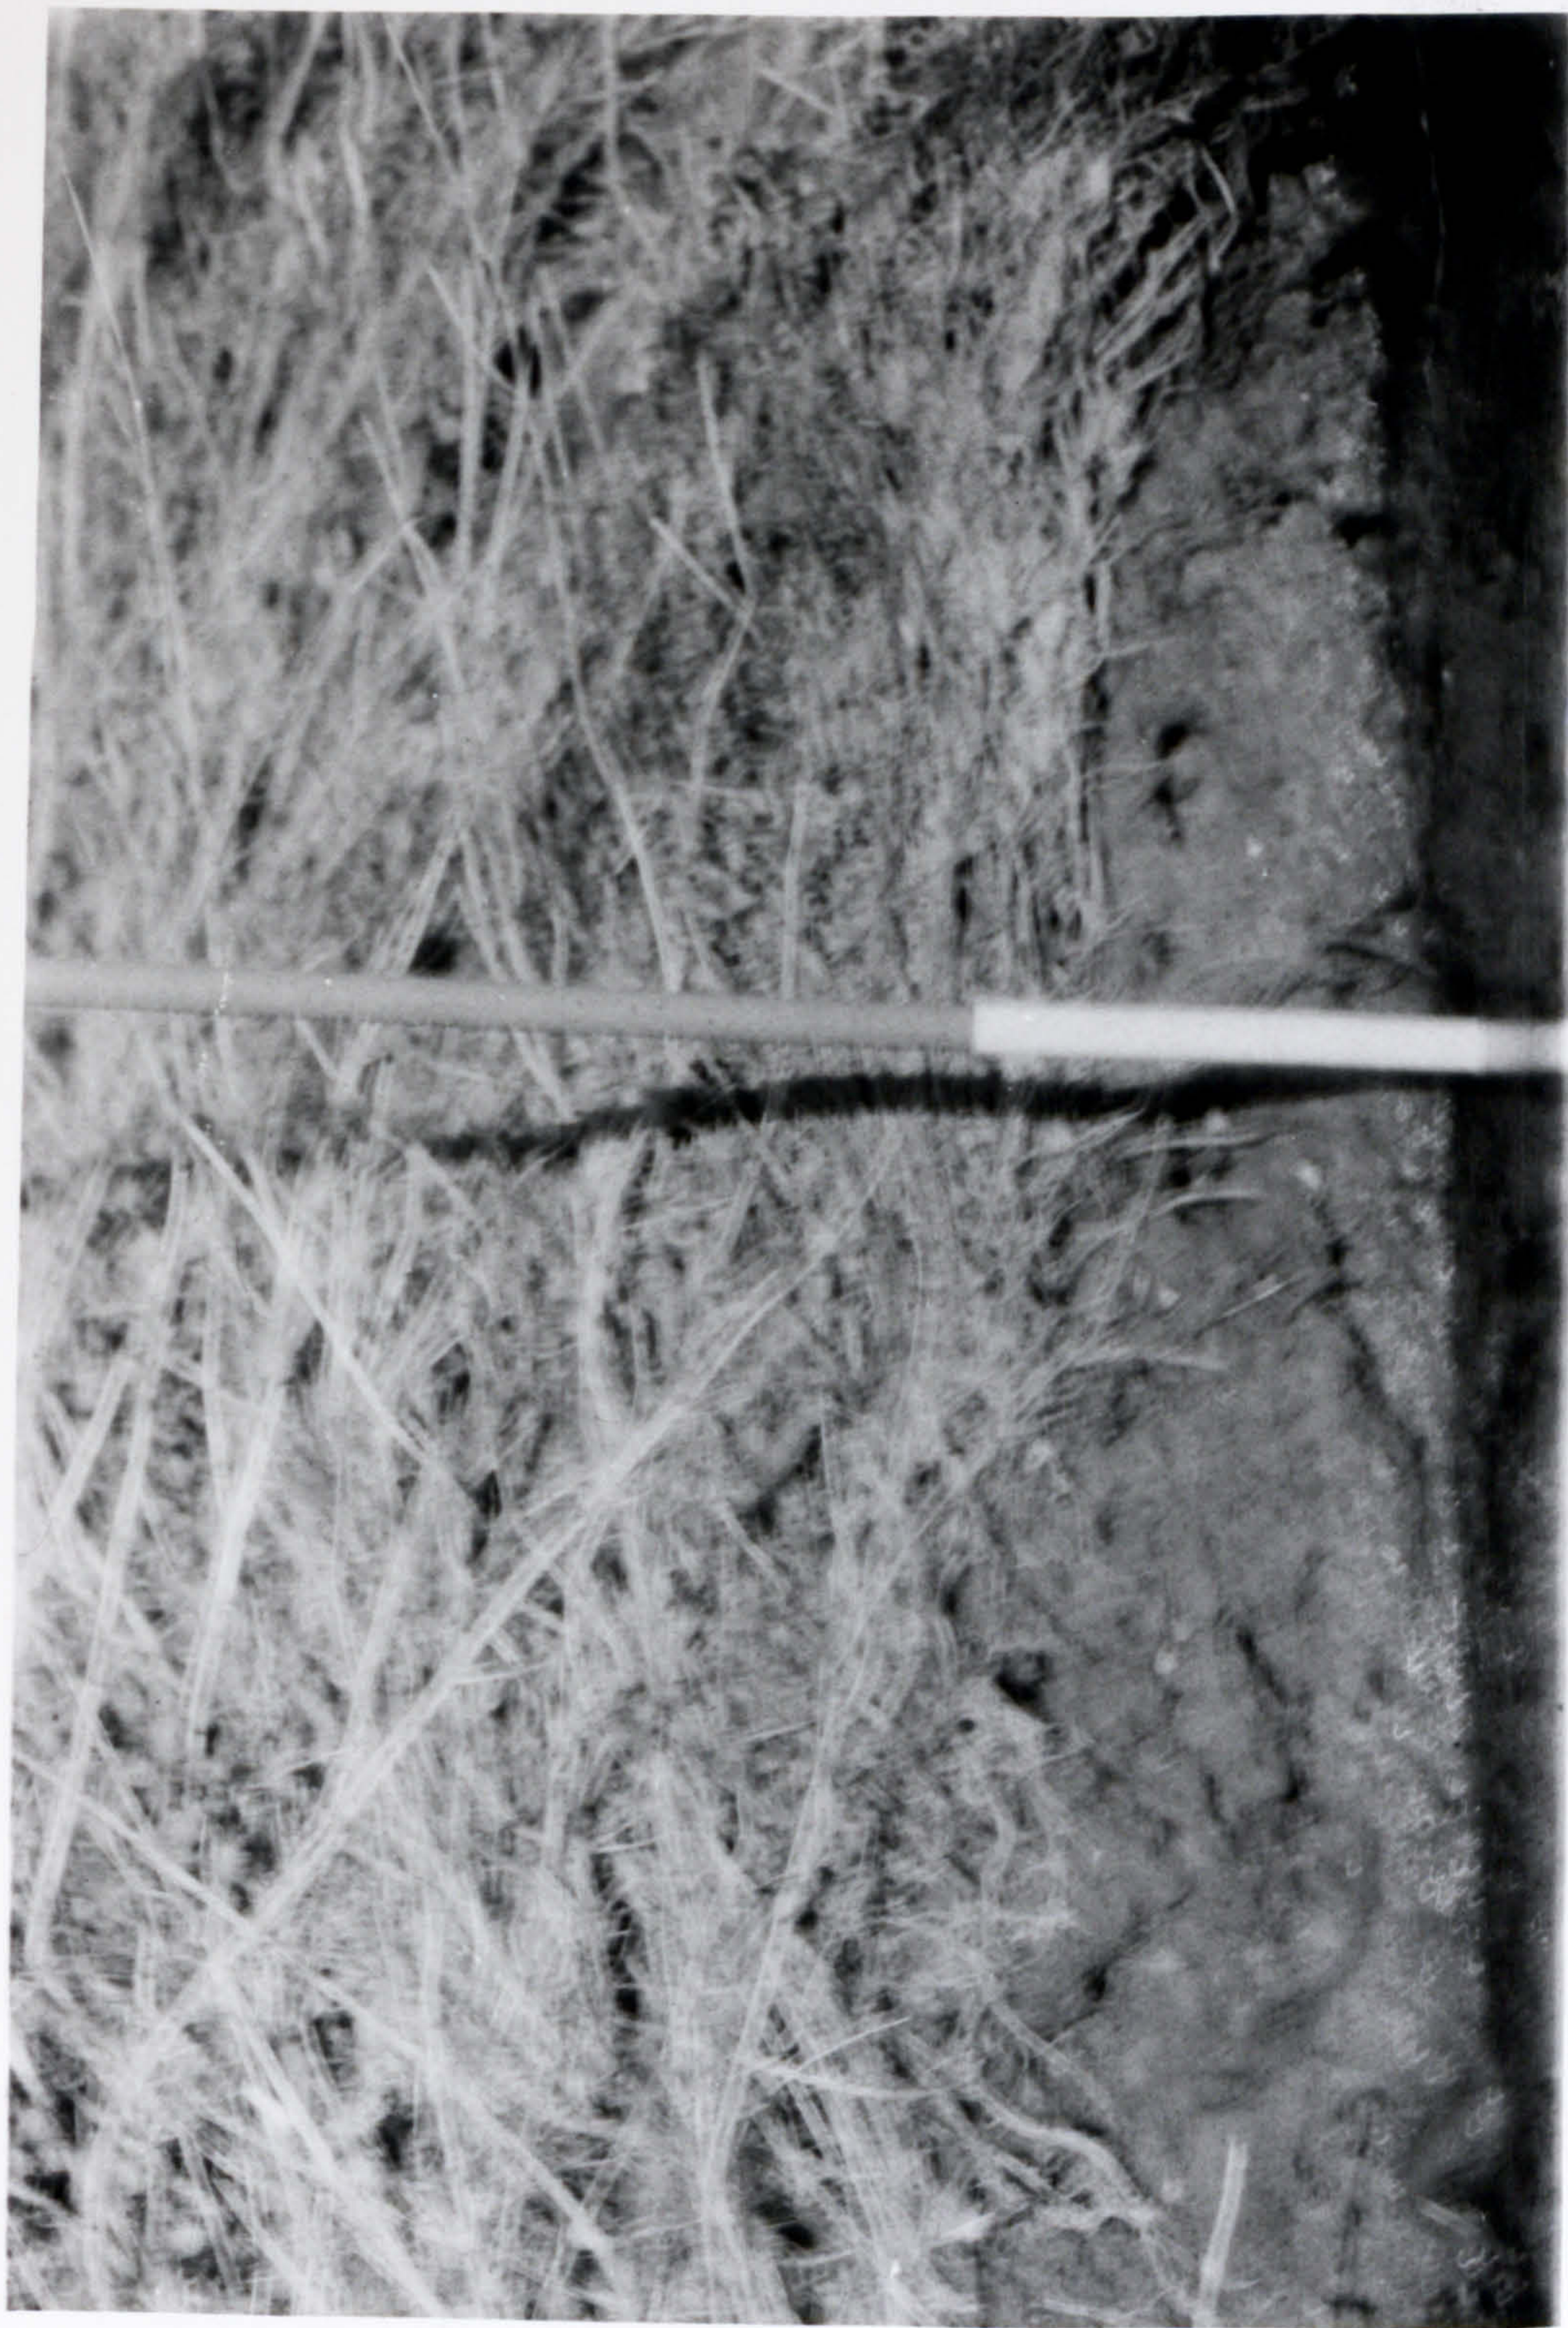
Plate 14. **Corrasion in the lower bank region of Normal vegetation due to lack of ban-toe fringe vegetation (post-flood period Oct. 1977 to Feb. 1988)**
N.B. matting of dead winter foliage oriented down river on the bank forming a 'protective cover/barrier)

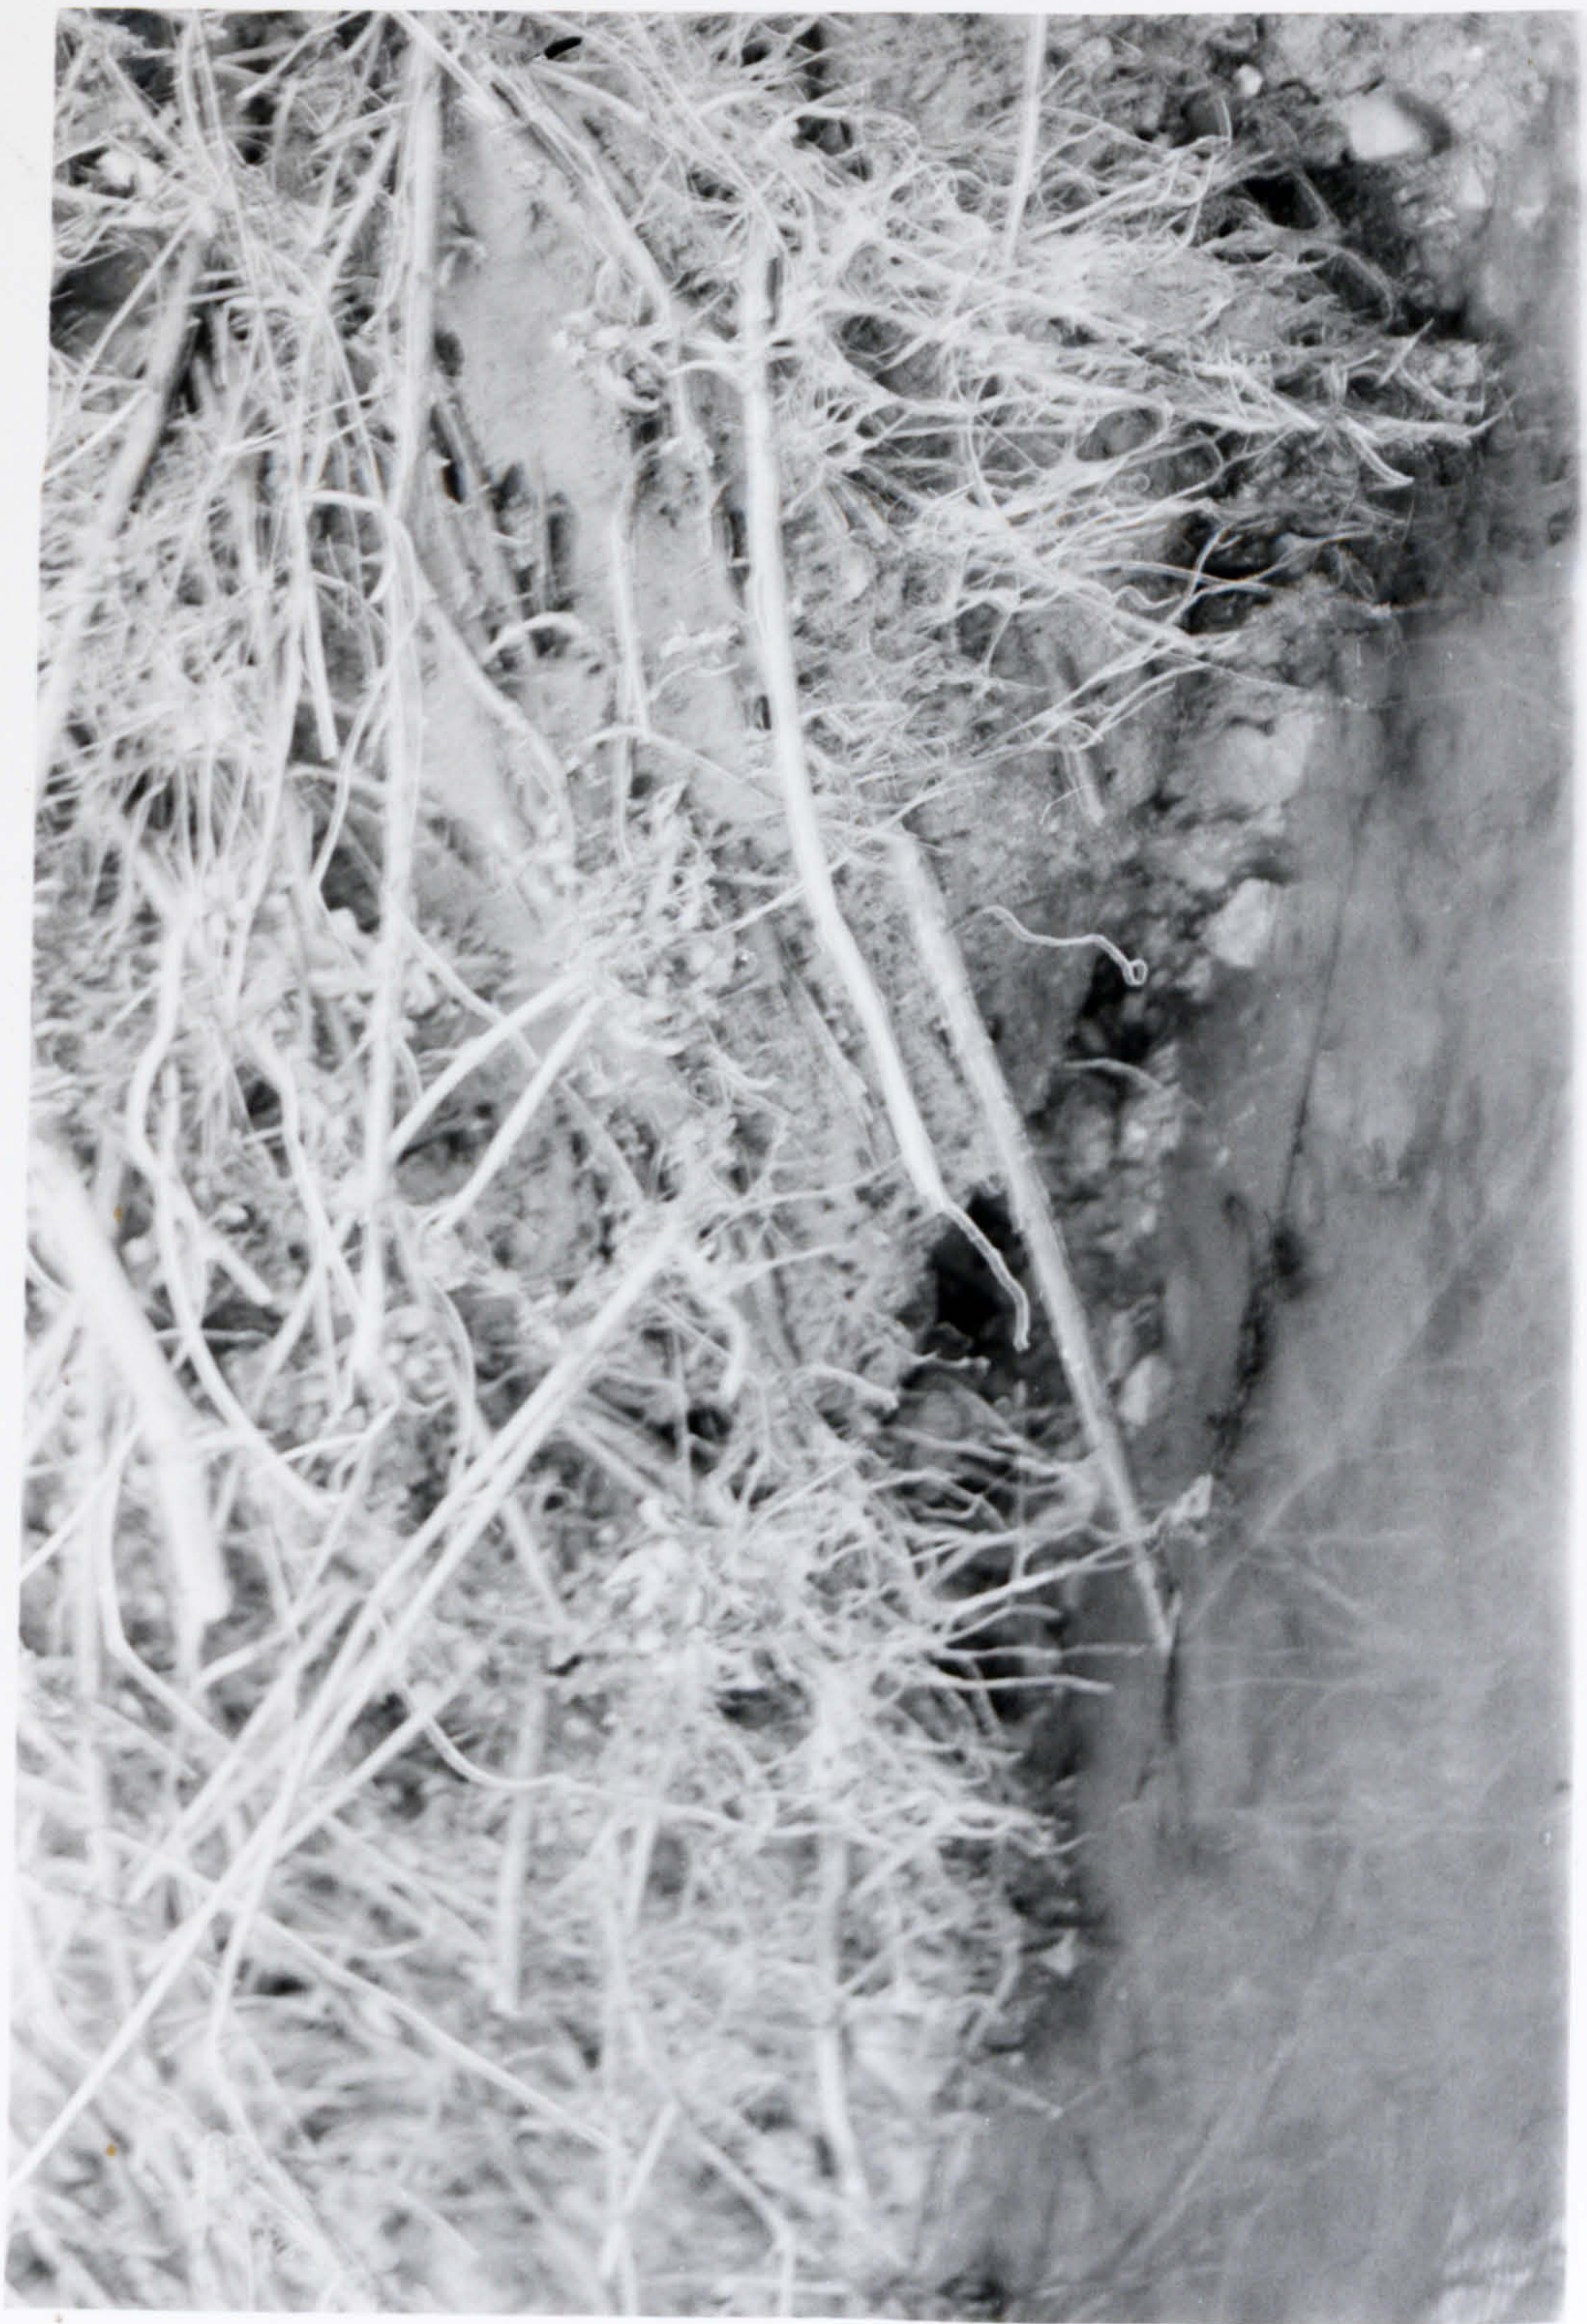
Plate 15. Undercutting at bank-toe of long established Normal vegetation;
 Observe lack of fringe vegetation
 N.B. dead skeletal shoot system (a) covering the bank, and (b) acting as a silt trap
